# COMBINED FIRE AND HEALTH & SAFETY RISK ASSESSMENT.

Address of premises:	1-18 Towpath Gardens, The Moorings, Swindon, SN1 5AD
Responsible Person:	Towpath Gardens RTM Company Ltd
Duty Holder:	Block Management LTD
Person(s) consulted:	No occupier or other relevant person available to consult.
Assessor:	Rob Cockburn
Report validated by:	John Godfrey, GIFireE.
Date of fire risk assessment:	4 <sup>th</sup> March 2025/ Reviewed June 2026
Date of previous fire risk assessment:	14 <sup>th</sup> March 2023
Suggested date for review:	March 2027

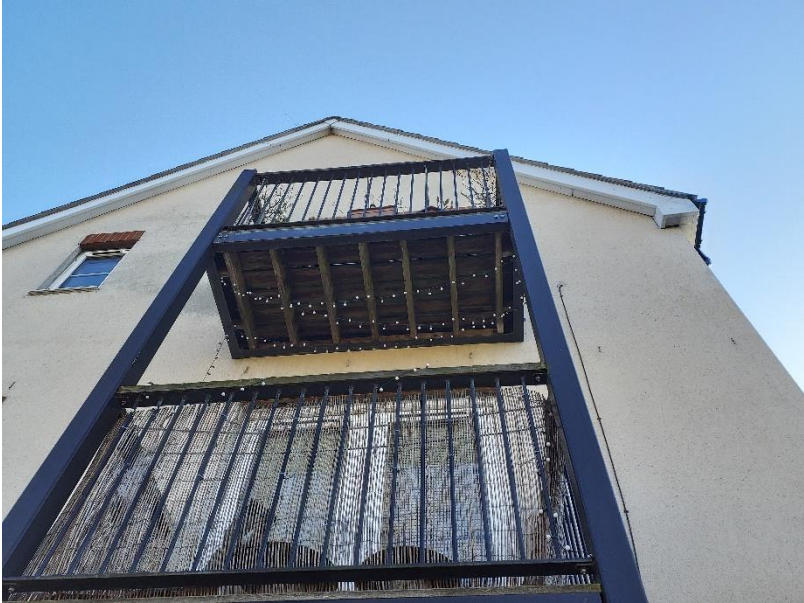
Item	Recommendation	Priority	Timescale
01	<p>It was noted during this assessment that numerous balconies have timber flooring. It is recommended that these timber balconies be upgraded or replaced with suitable fire-resistant materials capable of providing a minimum of thirty minutes fire resistance in order to reduce the external spread of fire.</p>

Action Required  
To be actioned during routine replacement  
Balcony owners to be provided with additional safety information.

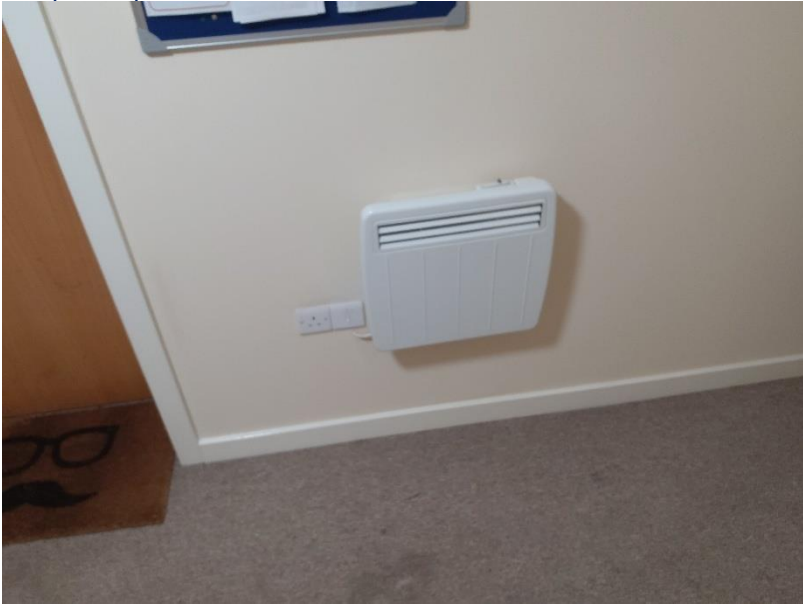
<p>03</p>	<p>The communal areas are heated by wall mounted electrical heaters, it is recommended that these be inspected and tested by a competent person in line with the fixed electrical installation.</p>

<p>The photograph shows a white, rectangular wall-mounted electrical heater. It is mounted on a light-colored wall. Below the heater, there is a standard electrical socket. The heater has a control panel on its front face.</p>	<p>3</p>	<p>C</p>	<p>Action required</p> <p>RP to consider removal of units during redecoration.</p> <p>Units are turned off at consumer unit.</p>

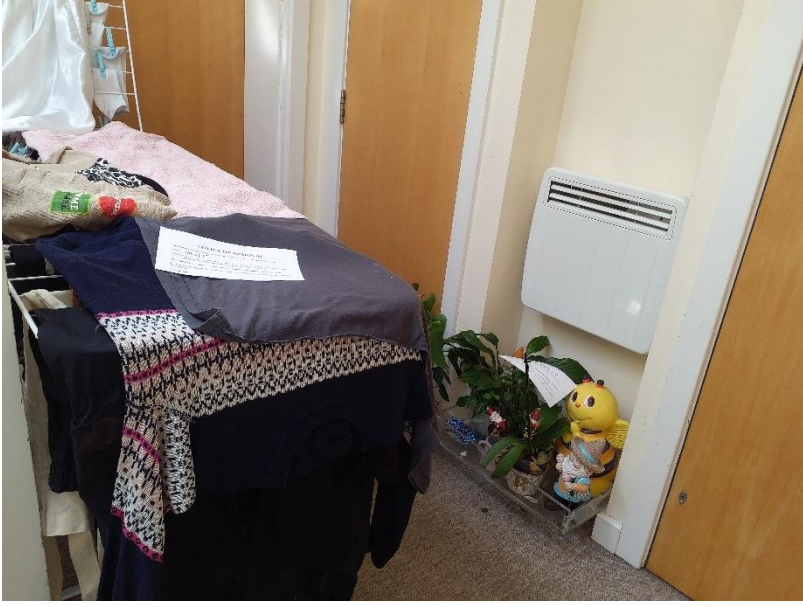
<b>04</b>	<p>Housekeeping was found to be satisfactory at the time of this assessment within Block communal area to flats 1, 2, 3, 5, 6 and 10 and Block communal area to flats 4, 7, 8, 9, 11 and 12. All common areas and escape routes found to be free of combustibles and residents' storage. Care must be taken to avoid obstructing or blocking fire exit routes and this area must be monitored at all times.</p>	3	C	<p>Ongoing action required DH inspect communal areas</p>
<b>05</b>	<p>Housekeeping was found to be of a poor standard at the time of this assessment within Block communal area to flats 13-18 with the communal areas and escape routes congested with residents' possessions and storage. It is recommended that the client arrange for the communal areas to be cleared as a priority and all residents reminded of the importance of maintaining sterile communal areas and escape routes.</p>

2	B	<p>Ongoing action required DH inspect communal areas and ticket items for removal. Residents are reminded of sterile area policy via noticeboard</p>

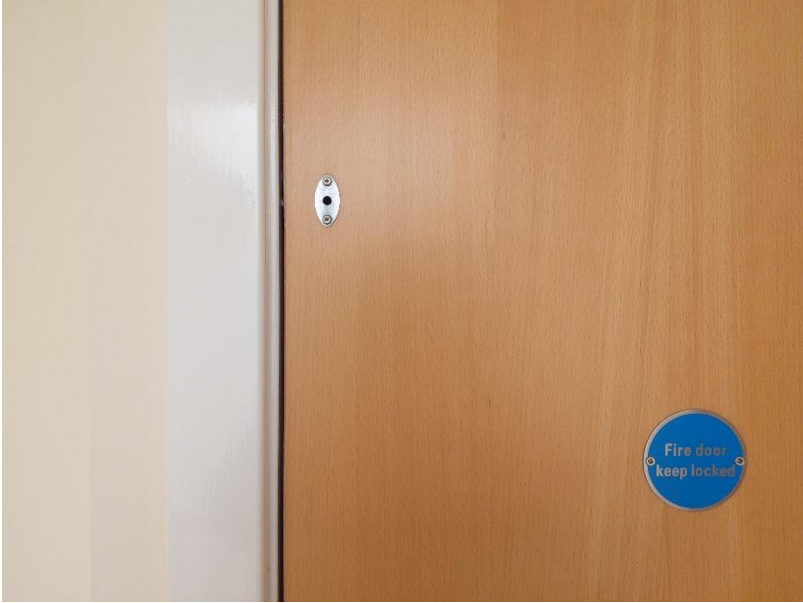
<p>07</p>	<p>All riser doors in all blocks and the understairs cupboard door in block communal area to flats 13-18 could not be accessed due to the lock mechanism installed. It could be considered by the RP for these lock mechanisms to be changed to an FB2 lock mechanism to be uniform with the electrical intake cupboard door of each block and allow future inspections. All work should be done by a suitably qualified and competent contractor.</p>

<p>3</p>	<p>B</p>	<p>Action required RP to consider replacement locks. Access key is via rackbolt available via DH.</p>
<p>08</p>	<p>It was noted during this fire risk assessment that the lock plate on the electrical intake cupboard frame in block communal area to flats 1, 2, 3, 5, 6 and 10 was missing which could affect the integrity of the frame and/or allow smoke to pass through the gap left by the missing lock plate. It is therefore recommended that the RP instructs a suitably qualified and competent contractor to install a new high temperature lock plate in order to maintain the integrity of the frame and door set.</p>

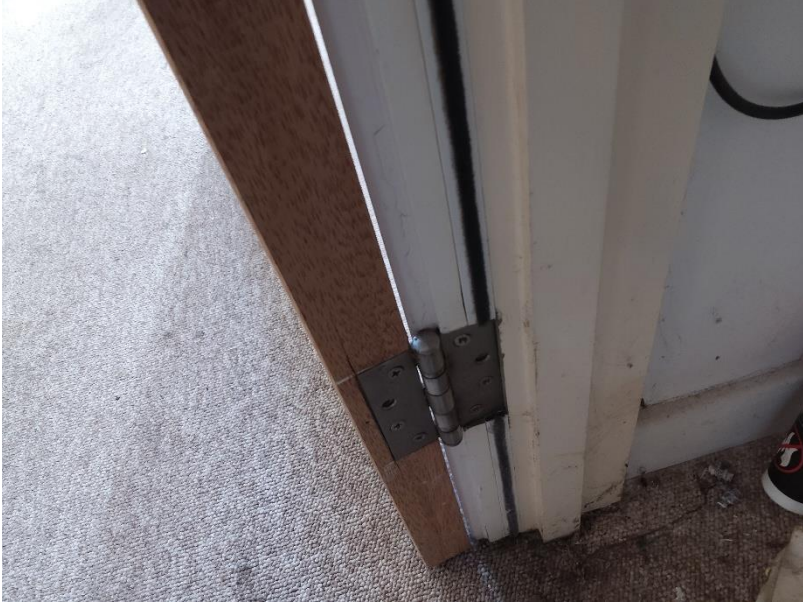
<p>09</p>	<p>It was noted during this fire risk assessment that the bottom hinge on the electrical intake cupboard door within block communal area to flats 13-18 was missing screws. This could affect the integrity of the door set causing it to fail in the event of a fire. It is therefore recommended that the RP instructs a suitably qualified and competent contractor to install new screws which are in tandem with the door set.</p>

<p>2</p>	<p>C</p>	<p>Action complete Residents are reminded on importance of fire doors via notice board and email.</p>
<p>10</p>	<p>It was noted during this fire risk assessment that the ground floor lobby door in block communal area to flat 13-18 did not fully self-close which could allow smoke to pass into the means of escape. It is therefore recommended that the RP ease and adjust the closer to ensure the door has complete self-closure.</p>

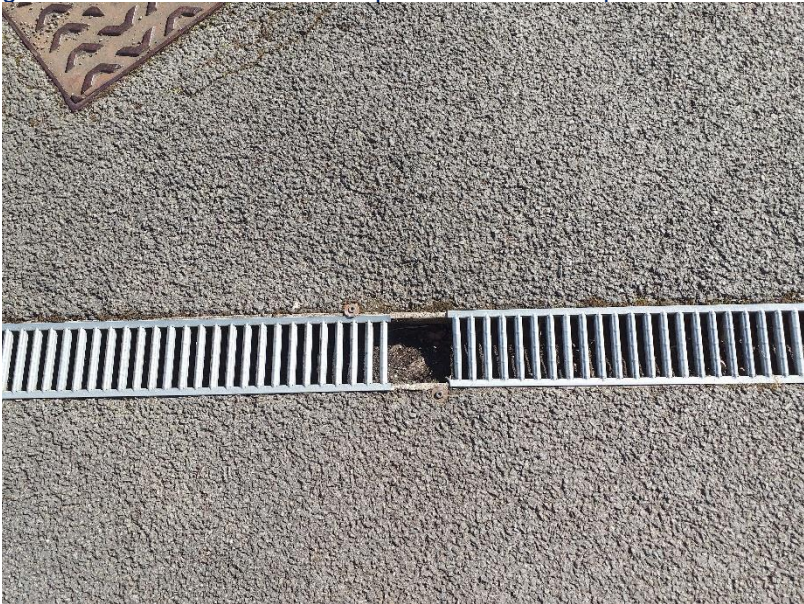
<b>19</b>	<p>The surrounding areas of the premises including hard and soft landscaping and car parking areas were found to be in good visual condition with paved and Tarmacked surfaces reasonably level and free from major indentations or potholes.</p> <p>Landscaping &amp; external grounds maintenance is of an acceptable standard.</p> <p>These areas should be periodically inspected by the RP and the results of each inspection recorded.</p>	3	C	Ongoing action required DH inspect communal areas
<b>20</b>	<p>It was noted during this assessment that the carpark gutter grate had a large piece missing which could present a tripping hazard. It is recommended that the RP has this replaced allowing the gutter grate to be continuous and complete across the required area.</p>

2	C	Action required ACO drainage recently replaced. Area is monitored for uplifting and other issues
