COMBINED FIRE AND HEALTH & SAFETY RISK ASSESSMENT.

Address of premises:	1-18 Towpath Gardens, The Moorings, Swindon, SN1 5AD
Responsible Person:	Towpath Gardens RTM Company Ltd
Duty Holder:	Block Management LTD
Person(s) consulted:	No occupier or other relevant person available to consult.
Assessor:	Rob Cockburn
Report validated by:	John Godfrey, GIFireE.
Date of fire risk assessment:	4 th March 2025
Date of previous fire risk assessment:	14 th March 2023
Suggested date for review:	March 2026

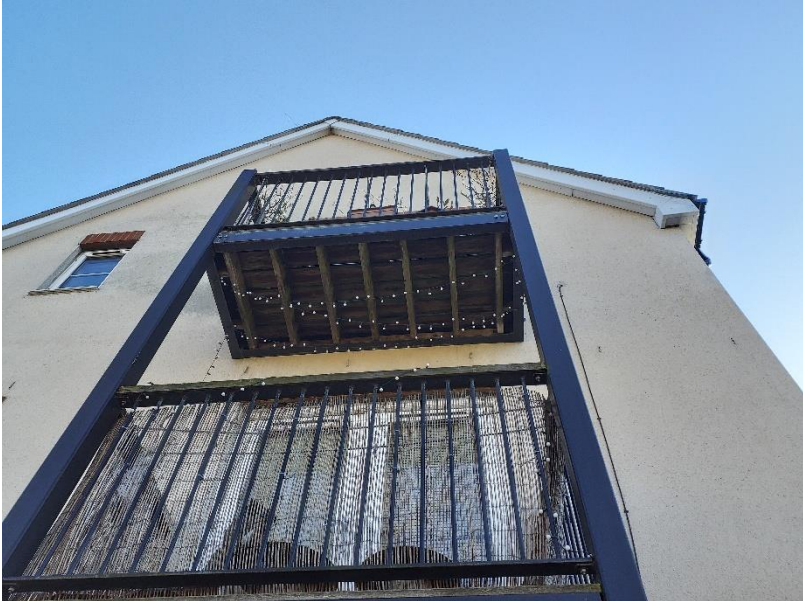
Item	Recommendation	Priority	Timescale
01	<p>It was noted during this assessment that numerous balconies have timber flooring. It is recommended that these timber balconies be upgraded or replaced with suitable fire-resistant materials capable of providing a minimum of thirty minutes fire resistance in order to reduce the external spread of fire.</p>

2	B

Action Required

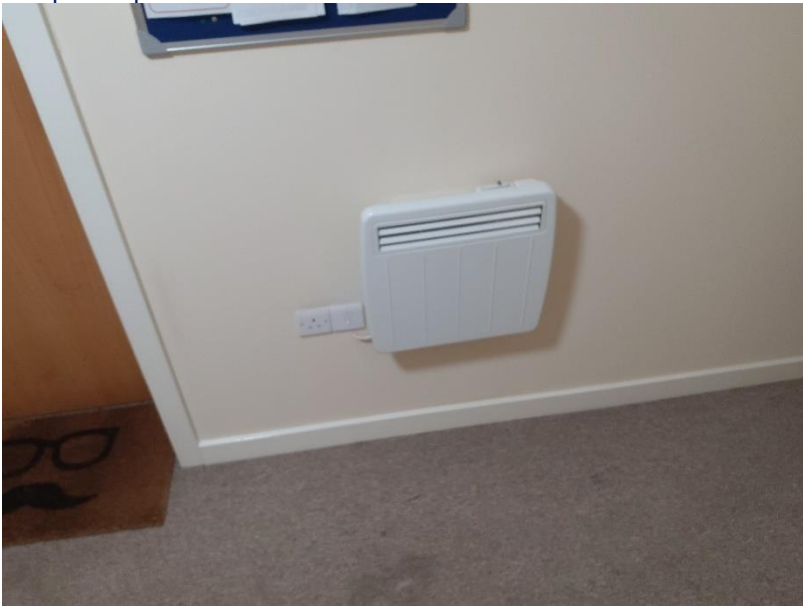
<p>03</p>	<p>The communal areas are heated by wall mounted electrical heaters, it is recommended that these be inspected and tested by a competent person in line with the fixed electrical installation.</p>

<p>The photograph shows a white, rectangular wall-mounted electrical heater. It is mounted on a light-colored wall. To the left of the heater, there is a white electrical outlet. The heater has a control panel on its front face.</p>	<p>3</p>	<p>C</p>	<p>Action required</p> <p>RP to consider removal of units during redecoration.</p>

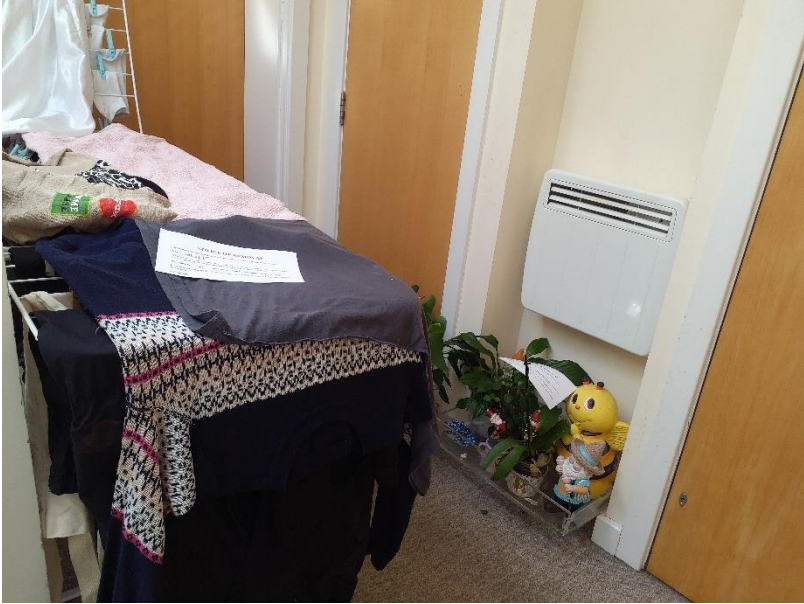
04	<p>Housekeeping was found to be satisfactory at the time of this assessment within Block communal area to flats 1, 2, 3, 5, 6 and 10 and Block communal area to flats 4, 7, 8, 9, 11 and 12. All common areas and escape routes found to be free of combustibles and residents' storage. Care must be taken to avoid obstructing or blocking fire exit routes and this area must be monitored at all times.</p>	3	C	<p>Ongoing action required DH inspect communal areas</p>
05	<p>Housekeeping was found to be of a poor standard at the time of this assessment within Block communal area to flats 13-18 with the communal areas and escape routes congested with residents' possessions and storage. It is recommended that the client arrange for the communal areas to be cleared as a priority and all residents reminded of the importance of maintaining sterile communal areas and escape routes.</p>

2	B	<p>Ongoing action required DH inspect communal areas and ticket items for removal. Residents are reminded of sterile area policy via noticeboard</p>

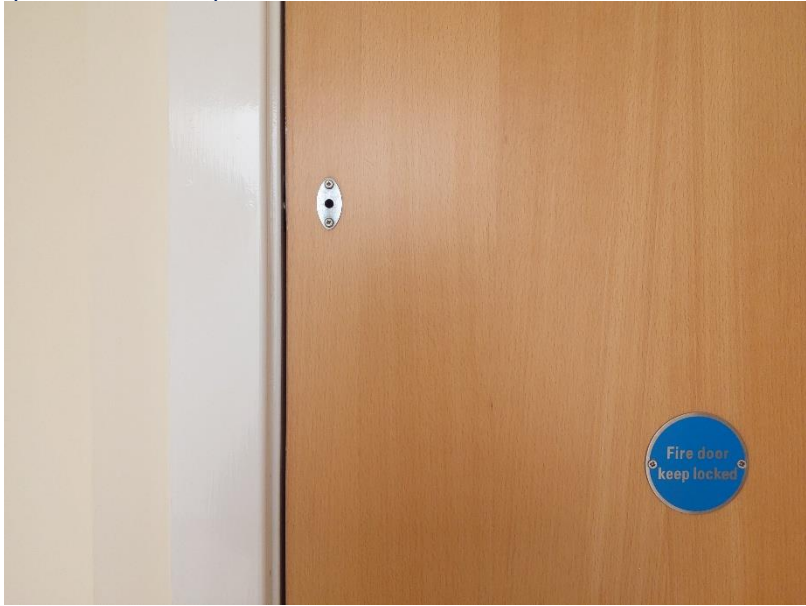
<p>07</p>	<p>All riser doors in all blocks and the understairs cupboard door in block communal area to flats 13-18 could not be accessed due to the lock mechanism installed. It could be considered by the RP for these lock mechanisms to be changed to an FB2 lock mechanism to be uniform with the electrical intake cupboard door of each block and allow future inspections. All work should be done by a suitably qualified and competent contractor.</p>

Action required
RP to consider replacement locks.
Access key is via rackbolt available via DH.

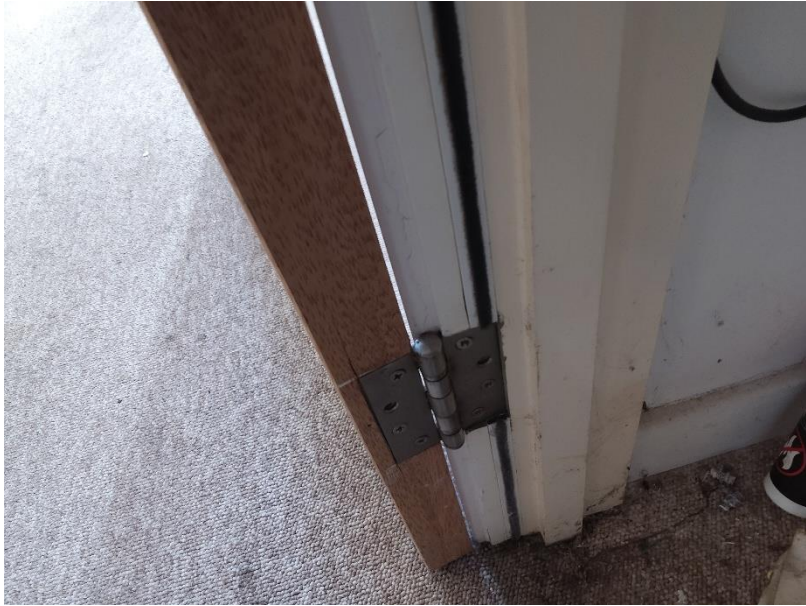
<p>09</p>	<p>It was noted during this fire risk assessment that the bottom hinge on the electrical intake cupboard door within block communal area to flats 13-18 was missing screws. This could affect the integrity of the door set causing it to fail in the event of a fire. It is therefore recommended that the RP instructs a suitably qualified and competent contractor to install new screws which are in tandem with the door set.</p>

<p>2</p>	<p>C</p>	<p>Action required Contractor to action</p>
<p>10</p>	<p>It was noted during this fire risk assessment that the ground floor lobby door in block communal area to flat 13-18 did not fully self-close which could allow smoke to pass into the means of escape. It is therefore recommended that the RP ease and adjust the closer to ensure the door has complete self-closure.</p>

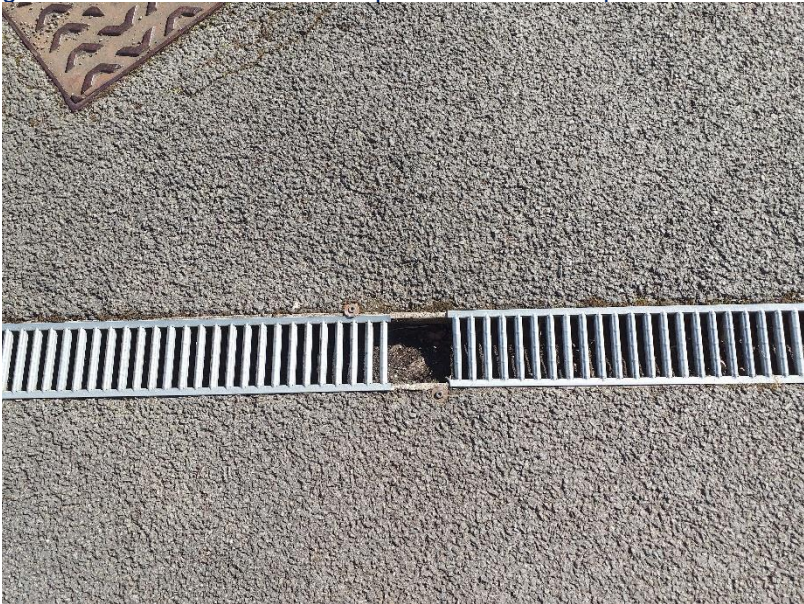
19	<p>The surrounding areas of the premises including hard and soft landscaping and car parking areas were found to be in good visual condition with paved and Tarmacked surfaces reasonably level and free from major indentations or potholes.</p> <p>Landscaping & external grounds maintenance is of an acceptable standard.</p> <p>These areas should be periodically inspected by the RP and the results of each inspection recorded.</p>	3	C	Ongoing action required DH inspect communal areas
20	<p>It was noted during this assessment that the carpark gutter grate had a large piece missing which could present a tripping hazard. It is recommended that the RP has this replaced allowing the gutter grate to be continuous and complete across the required area.</p>

2	C	Action required ACO drainage recently replaced and repaired. Contractor to action additional repair
